# DRIVE Marine Services

## WHY CLEAR COATINGS FAIL

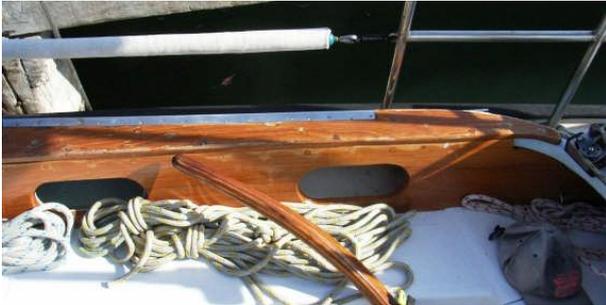
**Figure 1-** Varnish Breakdown on Teak

**Note:** *The timberwork in Figure 1 is normally covered with specially made Sunbrella covers when not in use which shows how moisture was the significant influence of deterioration, not UV on varnished surfaces.*

1. **Oil Based Varnishes** – Most are only 60 to 65% waterproof and unless there are 6 to 8 coats applied, they start to fail by cracking in six (6) to twelve (12) months, if not sanded and recoated. The reason they fail in a relatively short time is that the moisture finds its way through to the timber which causes increased expansion & contraction due to the daily temperature and humidity changes. The other limitation of varnish is that the oil leaches out as it ages and it becomes more brittle; the result is cracking as it becomes too brittle to handle the expansion of the timber as the moisture level increases. By sanding and applying fresh coats of

varnish regularly it rejuvenates the surface to keep it supple. The other limitation of cheaper varnishes is that they yellow off or darken as they age. With modern coatings available, they should be relegated to interior use only unless you have a love of sanding and the smell of freshly applied varnish.

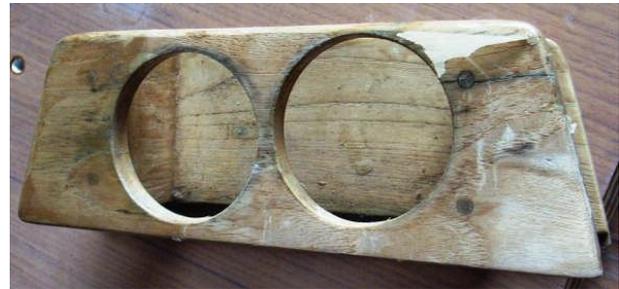
**Figure 2 -** Teak Drink Holders with Polyurethane breakdown

2. **Two Pack Polyurethanes & Estapols** - Most are about 80 to 85% waterproof and depending on the number of coats (at least three are recommended) moisture will permeate through over eighteen months to three years, depending on the thickness of the coating, unless the surface is sanded and additional coats applied every twelve to eighteen months. Even Aquacote Topcoat will fail in two to three years in full exposure without recoating. The advantage Polyurethanes have over varnish is that they have very good UV resistance and set extremely tough and are very hard wearing. They remain supple, but they fail by the coating lifting off the surface as the moisture that penetrates through degrades the timber at the bond interface.

We do not recommend applying polyurethanes direct to timber for exterior applications due to the difficulty of removing it once the coating fails.

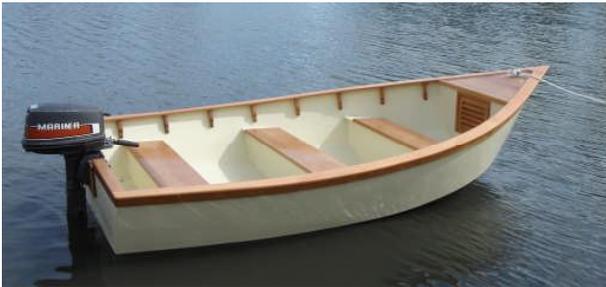
**Figure 3** – Runabout brightwork finished with the Clear System

4. **Clear System** – The ultimate exterior finish consists of three (3) coats of Bote-Cote Non-Yellowing Marine Epoxy resin and then three (3) coats of clear AQUACOTE Topcoat which ensures several years of protection with minimal maintenance. To maintain the

surface in good condition we recommend lightly sanding the surface every two to three years and applying another two coats of Aquacote Clear Topcoat to ensure continued good UV resistance and the surface remains in pristine condition. If you are like me and get sidetracked, at least keep an eye on the finish and if it starts to lose its gloss, get a couple more coats of AQUACOTE on as it is telling you the UV stabilisers are depleting. If not recoated at this stage, there is a good chance the surface will break down.

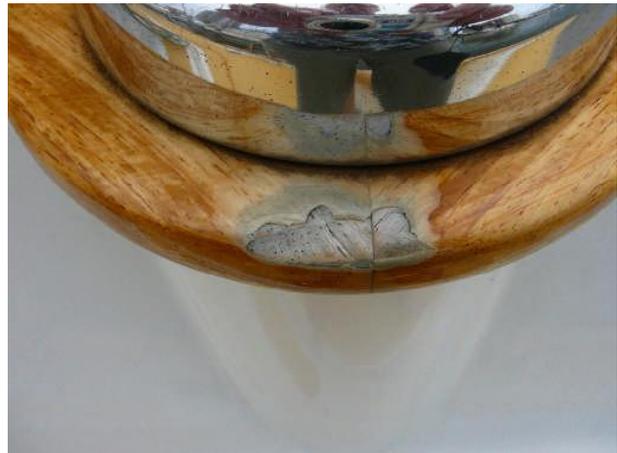
Figure 4 showing the winch is very telling as it shows where the sheet has rubbed over the brightwork and damaged it, which allowed moisture and UV rays to penetrate. You can see how the water is moving further under the coating, causing oxidation and damage to the timber and the de-lamination of the coating is spreading. The damage is absolutely confined to the locality of the failure of the protective film, which allowed moisture to enter. It is also pretty apparent that the degree of sun access to the area under the film which is failing is not a factor.

*Figure 4 – El Karim Clear system localised damage*

Figures 4 & 5 are two interesting photographs of brightwork in the cockpit of the 70 foot yacht, El Karim. Additional photographs of the brightwork can be seen at <http://elkarim.com/photo-gallery.php>. The surfaces were prepared with three (3) coats of Bote-Cote with NY Hardener, followed by three (3) coats of Aquacote Clear approximately six (6) years ago. Since then the boat has been across the Tasman 4 times, Fiji, Vanuatu, New Caledonia several times and now back in Australia. No maintenance has been carried out to this brightwork.

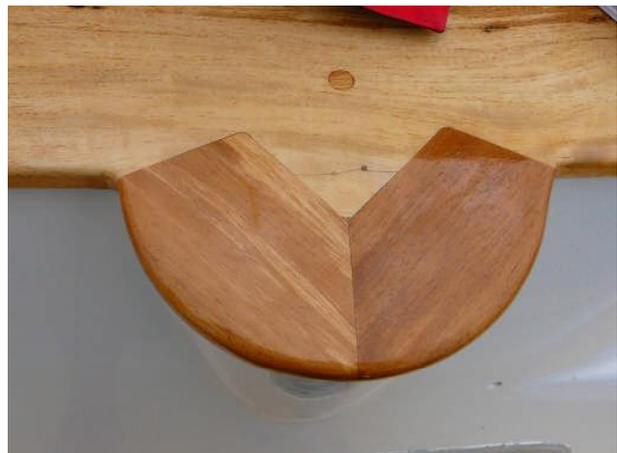
The other photograph is a spare winch pad which clearly demonstrates just how well the system holds up after 6 years. It is perfect, showing no signs of failure where the timber has remained sealed and therefore dry.

*Figure 5 – Spare Winch Pad in good condition after six years exposure using Clear System*
